NEW ROCHELLE RESERVOIR NO. 3

WESTCHESTER COUNTY, NEW YORK
INVENTORY NO. N.Y. 110

PHASE I INSPECTION REPORT
NATIONAL DAM SAFETY PROGRAM

HUTCHINSON RIVER BASIN
NEW ROCHELLE RESERVOIR NO. 3 DAM
I.D. No. N.Y. 110
Phase I Inspection Report

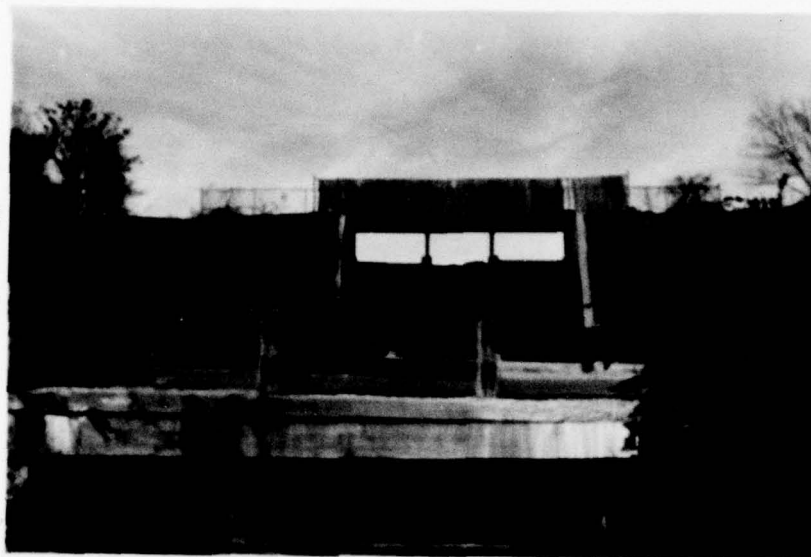
The channel beyond the end of the spillway is lined with concrete for several hundred feet. The channel passes under bridges for a bridle path, a highway ramp, and the Hutchinson River Parkway before re-entering the natural channel. The concrete in the channel was in good condition.

SPILLWAY CHANNEL LOOKING UPSTREAM

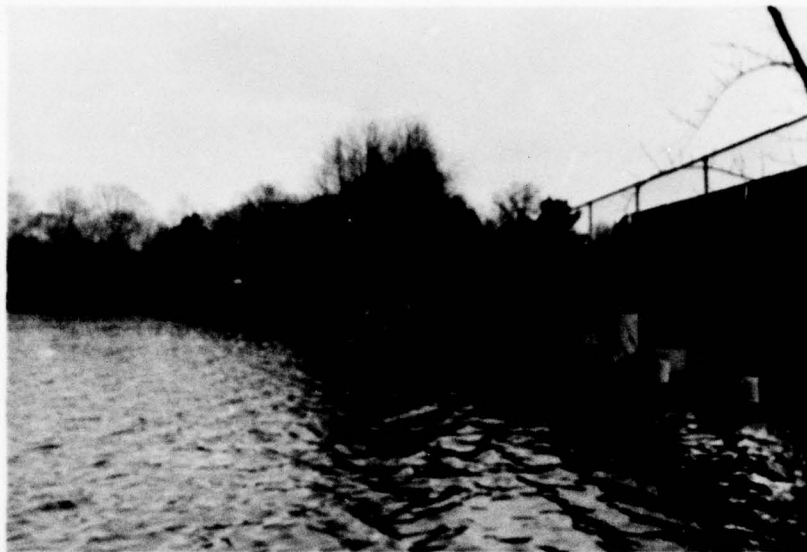
Visual observations of the reservoir drain were limited to inspection of the outlet and the valve control rod on the upstream slope. The drain outlets at the base of the spillway channel. A log was lodged in the semi-circular opening for the drain outlet. The valve control rod was bent and the frame supporting the rod was in need of repair.

UPSTREAM SLOPE OF DAM WITH VALVE CONTROL
ROD EXTENDING INTO RESERVOIR

- e. The reservoir drain control rod should be repaired and the drain made operational.
- f. A detailed emergency operation plan and warning system should be developed. Also, around-the-clock surveillance should be provided during periods of unusually heavy precipitation.
- g. Until the remedial mitigating measures rectifying the seriously inadequate status of the spillway have been completed, all stoplogs should be removed to provide increased spillway capacity.

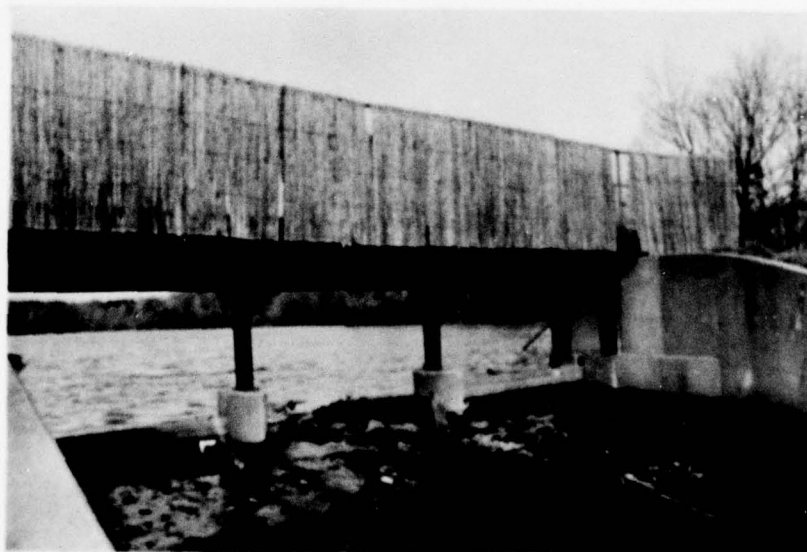
There are provisions for stoplogs under two of the three spans of the bridge. At the time of the inspection, three concrete stoplogs (1 foot total) were in place under the western span and 4 logs (1.4 feet) in under the eastern span. All of the logs in place were in good condition.

SPILLWAY CREST WITH CONCRETE STOP LOGS IN PLACE

around-the-clock surveillance should be provided during periods of unusually heavy precipitation. In addition, all stoplogs should be removed to provide increased spillway capacity.
